United States Department of the Interior

BUREAU OF LAND MANAGEMENT

Date: 08/20/10
To: Minerals Files UTU-69800, UTU-69812
From: Ted McDougall, Geologist
Subject: Surface Management Site Inspection, Denison Mines (USA) Corp, La Sal Mines (Pandora – UTU69800/M0370012; LaSal, Snowball and Beaver– UTU69812/M0370026), San Juan County, Utah.

Date of Inspection: 08/16/2010
Time of Inspection: 9:00 A.M.
Participants: Ted McDougall, Danny Flannery
Legal Description: T. 29 S., R. 24 E., Section 01
Claimant/Operator: Denison Mines
Bond Amount: \$175,811 for Pandora Mine
Date of Last Bond Review: 10/19/09 for Pandora Mine

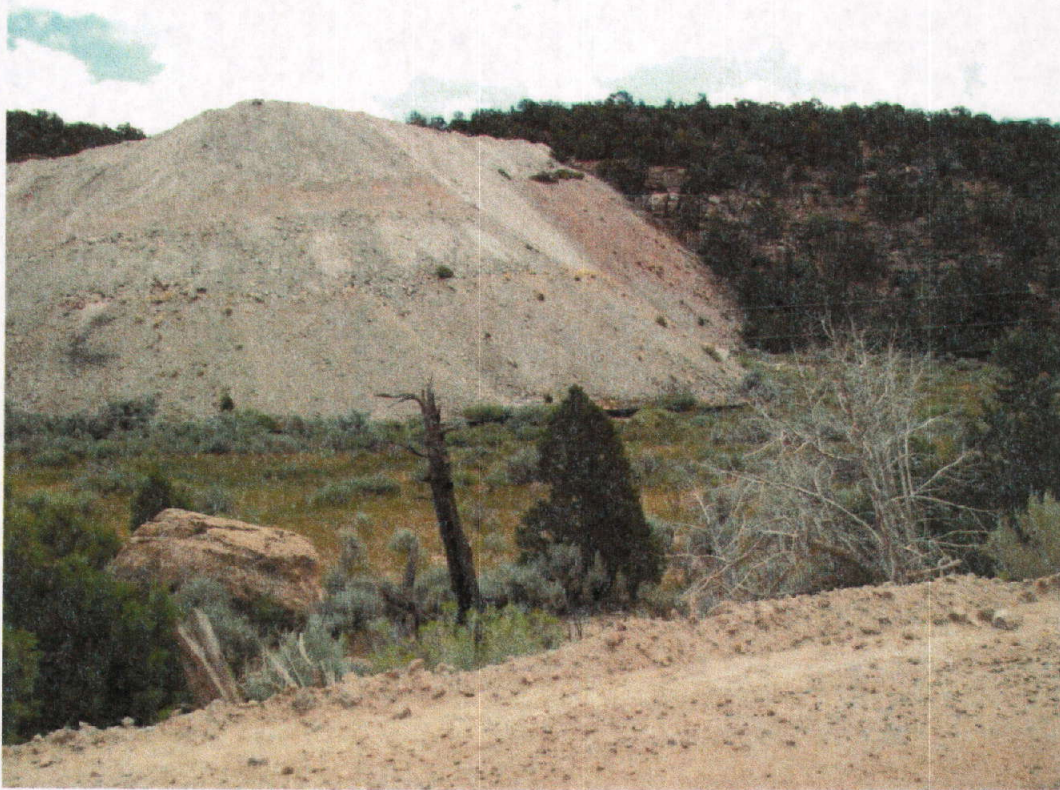
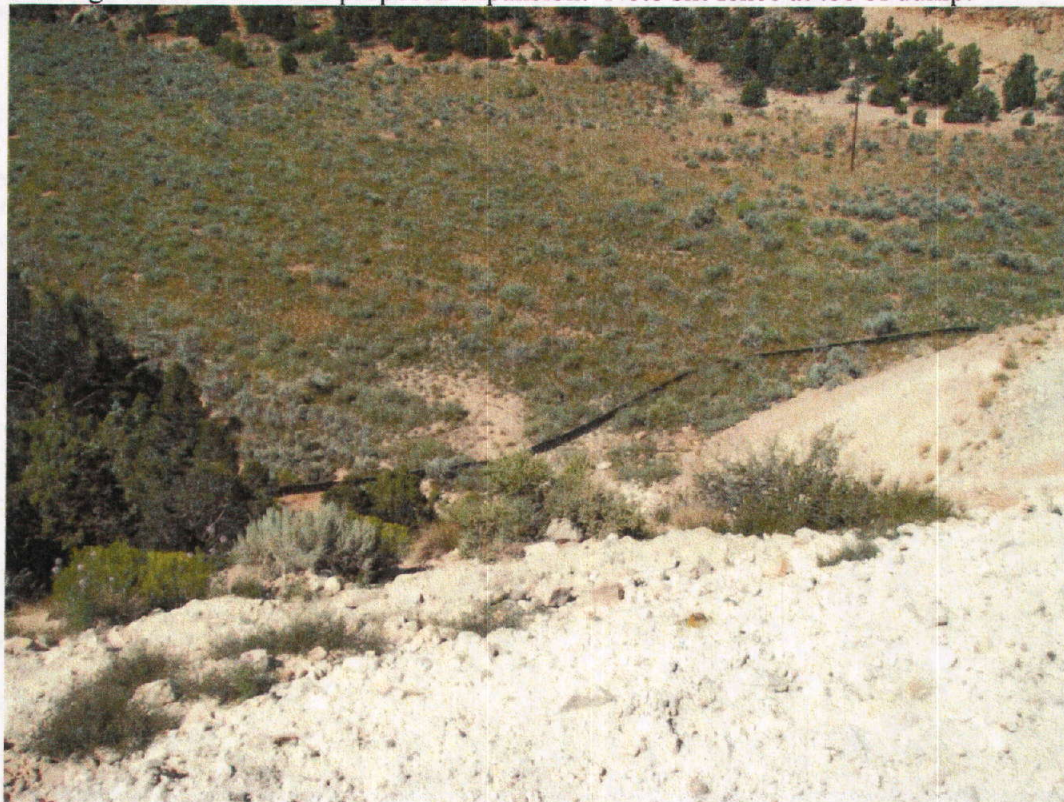
Waste Rock Disposal - The waste rock dump needs to be expanded to accommodate continued mine production. However, the toe of the dump occupies the full extent of the permit area. To avoid getting outside the permit area, the waste rock is simply being stacked higher on the top of the dump. There is some concern that the dump could become unstable if slopes are over steepened. However, I didn't observe any excessive erosion or other signs of slope instability. The slope of the dump appears to be maintained at the material's angle of repose. The bigger problem for the operation may be the loss of available space for waste rock disposal. As the dump gets higher, the surface area on top of the dump becomes smaller and the haul route becomes steeper. There is also a concern for proper storm water control because of the dumps encroachment against and onto the canyon rim. Expansion of the dump would alleviate the concern but, extending the dump beyond its current footprint requires a Plan Modification. In December 2009, the Moab Field Office received a Plan Modification for the LaSal Mines Complex which includes the needed dump expansion at the Pandora Mine. Approval of that modification is still pending. After reviewing the situation on site, it appears that it may be possible to pile some additional waste rock at the south end of the ore pad. This would not require a Plan Modification. However, sufficient area would have to be maintained for stockpiling ore and getting haul trucks in and out. Danny said he would follow-up with the contractor to see if there is room to accommodate temporary waste rock storage in that area. Should it become necessary, an alternative may be to haul waste rock from the Pandora Mine to the dump at the LaSal Incline.

Dump expansion will necessitate re-route of the natural drainage which requires a Stream Alteration Permit from the State of Utah. A silt fence has been installed along the toe of the dump. However, no catchment basins or diversion ditches for storm water were observed. These structures should be included in Denison's Storm Water Pollution Prevention Plan for the project.

Pandora Mine. Top – Waste rock dump; Bottom – View from top of dump looking toward the area of proposed expansion. Note silt fence at toe of dump.

- Denison Mines should consult with its contractor at the Pandora to determine if there is room to accommodate some interim stockpiling of waste rock on the far south end of the ore pad, adjacent to the existing waste rock dump. Should it become necessary, an alternative may be to haul waste rock from the Pandora Mine to the dump at the LaSal Incline.

- Unless previously included, Denison's Storm Water Pollution Prevention Plan (SPPP) for the project should include catchment basins to contain surface run-off from disturbed areas, including all of its waste rock dumps.

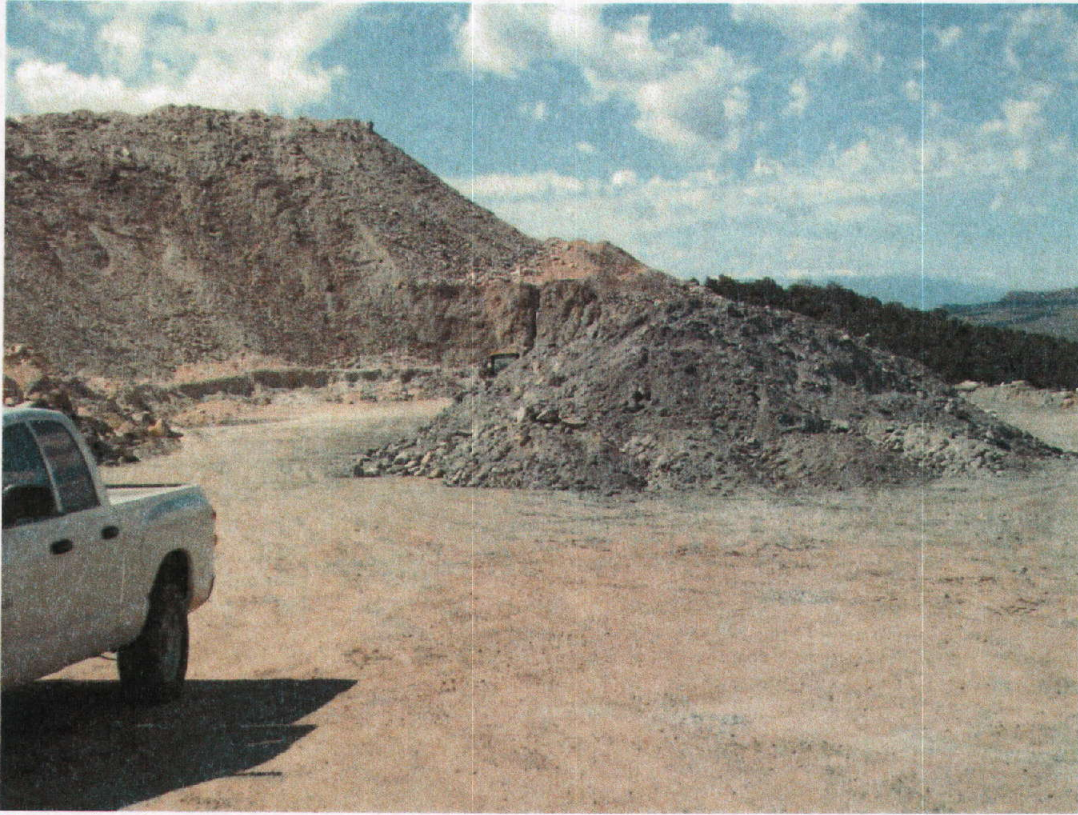
Ore pad at the Pandora Mine. Note possible area for interim storage of additional waste rock just beyond loader.

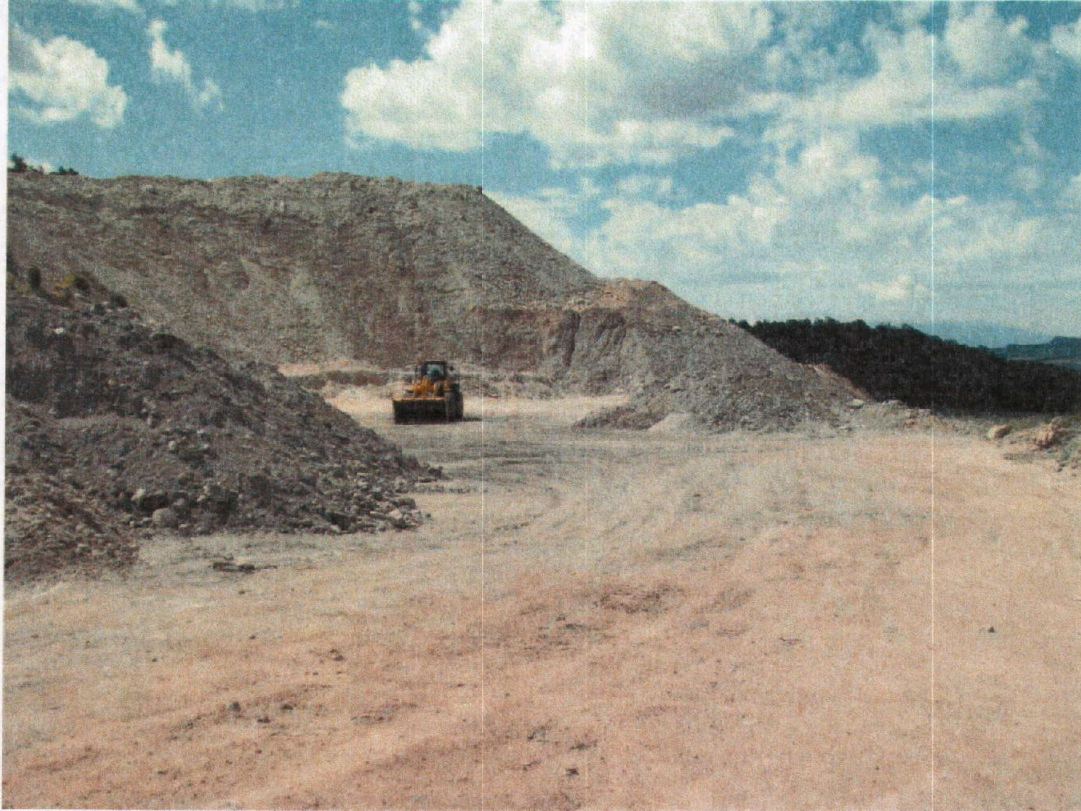
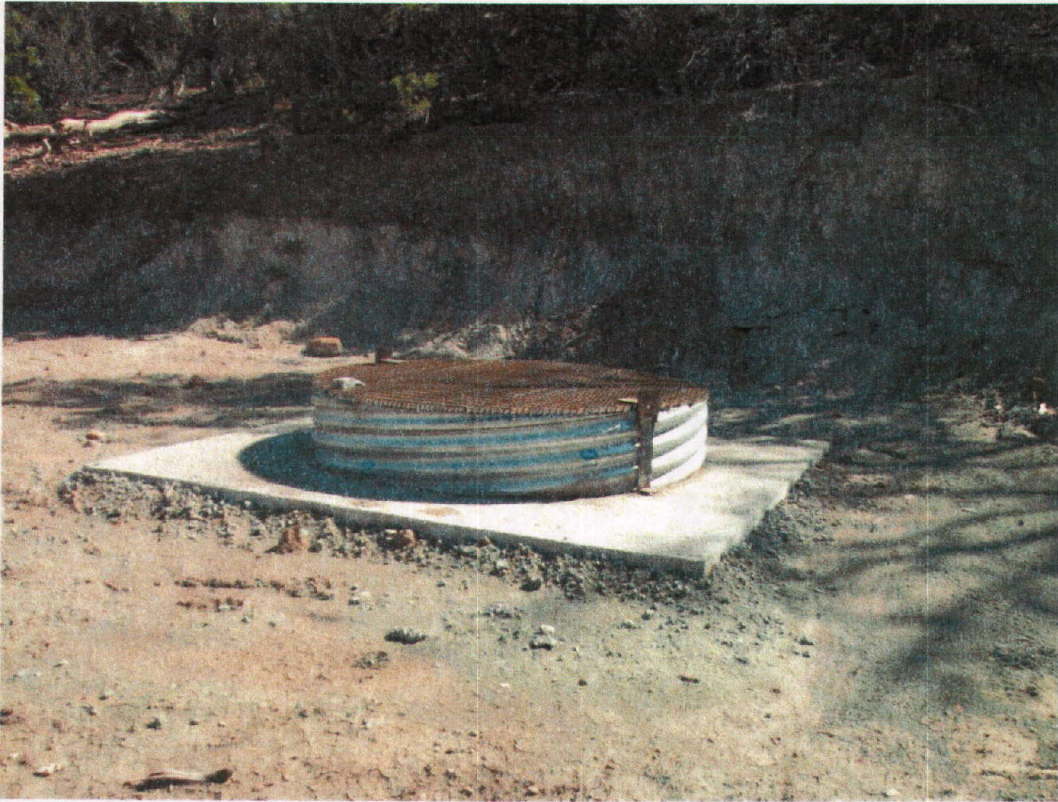
Danny and I visited the newly constructed vent 3-09, referred to by Denison as Pandora #12. A cut/fill pad has been constructed in the slope. A maximum cut of 8 feet occurs directly behind the vent. Total disturbance is estimated to be less than a ¼ acre. The vent hole is located on the northeast side of the pad, opposite the fill slope. The 6-ft borehole is lined at the surface with a galvanized culvert extending approximately 14 inches above a small concrete pad. The fan is located underground so there is no fan housing and diffuser at the surface. A steel grate is secured over the

opening. The disturbed area is larger than needed for future access and maintenance purposes so I talked to Danny about doing both concurrent and interim reclamation on site. The area south of the vent should be reclaimed. Concurrent reclamation can be done at that location by bringing the fill material back to the approximate slope contour and then seeding. The remaining area should have interim reclamation work done by dressing the western fill slope, pulling the trees back over the site and then seeding. Topsoil was not stockpiled on site as part of construction. Therefore, site reclamation should be monitored and if necessary, Denison could be required to apply soil amendments during final reclamation.

Newly constructed vent 3-09 (Pandora #12) and associated pad.

- Denison Mines should complete both concurrent and interim reclamation of the pad area at vent 3-09 (Pandora #12)
- The valley fill material underlying the area of the proposed Pandora Dump expansion may be a suitable source of growth medium for reclamation. Denison Mines should consider excavating the full depth of this material and stockpiling it for future reclamation use. The BLM should consider the handling of this material in its review of the proposed dump expansion.

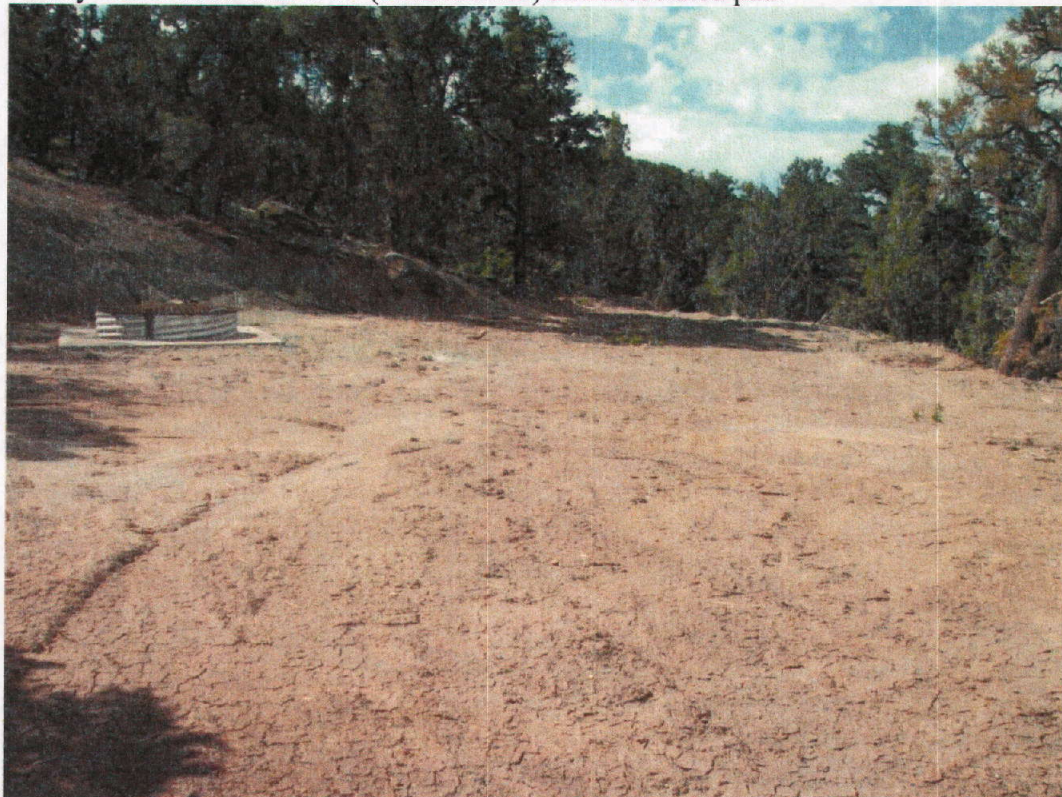
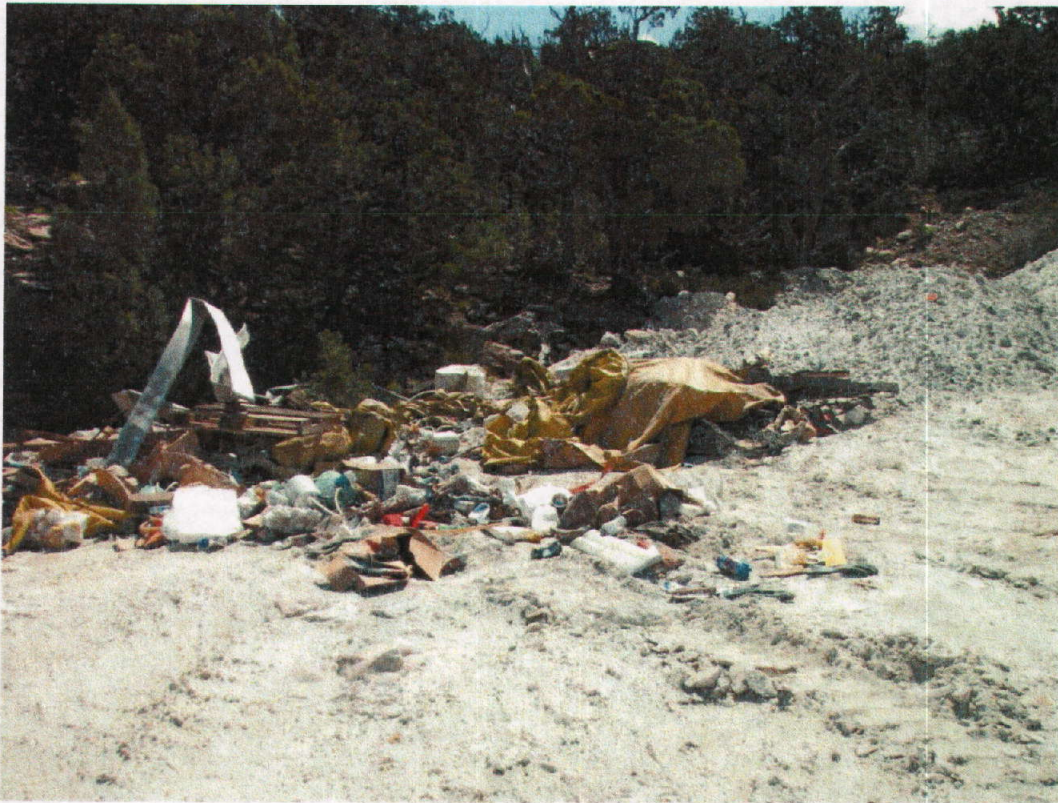
Other – A pile of discarded mine debris including, brattice, pallets, chain link, and common trash was located on top of the waste rock dump. We noted that the on-site trash container was nearly empty. We immediately went to the mine office and Danny talked to the mine foreman about the incident. He stressed that disposal of trash in the waste rock dump was not an acceptable practice. Before we left the site, a loader was dispatched to clean up the site.

Pandora Mine. Top - Trash dumped on the top of the waste rock pile; Bottom – nearly empty trash container.

- Denison Mines should continue to monitor its waste rock dumps to ensure that all trash is placed in the intended trash containers. All trash should then be hauled off site to an authorized disposal facility.

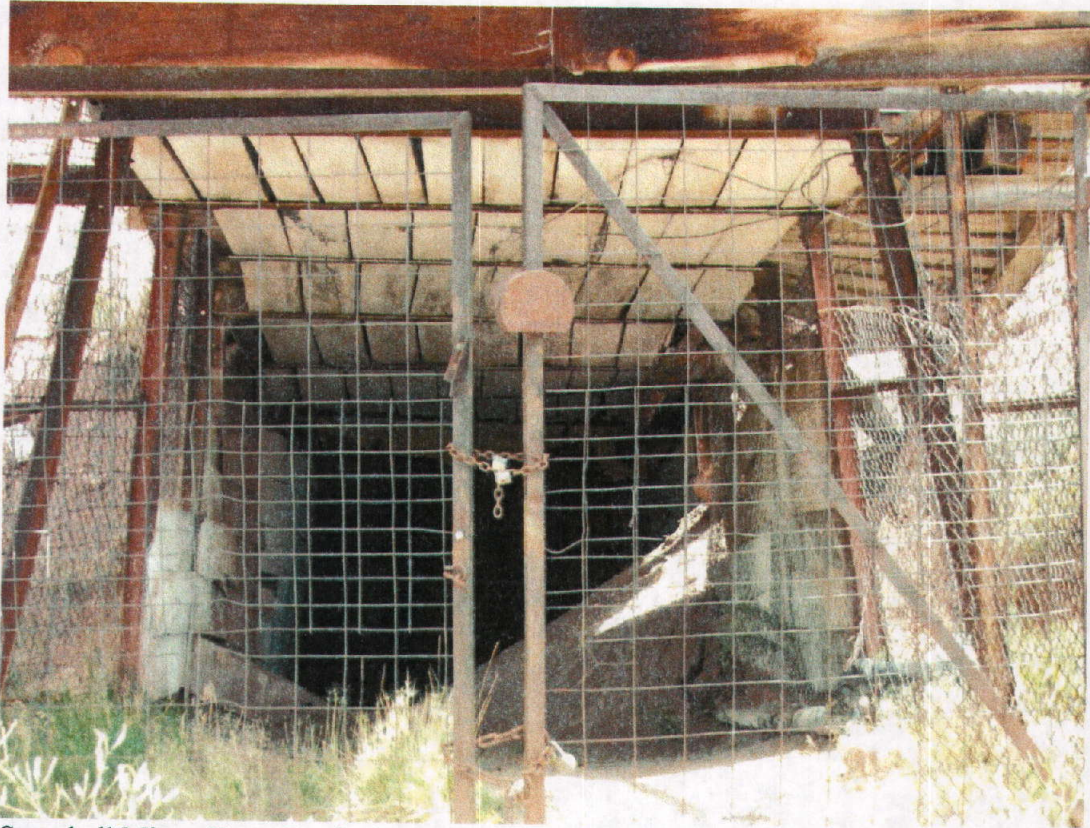
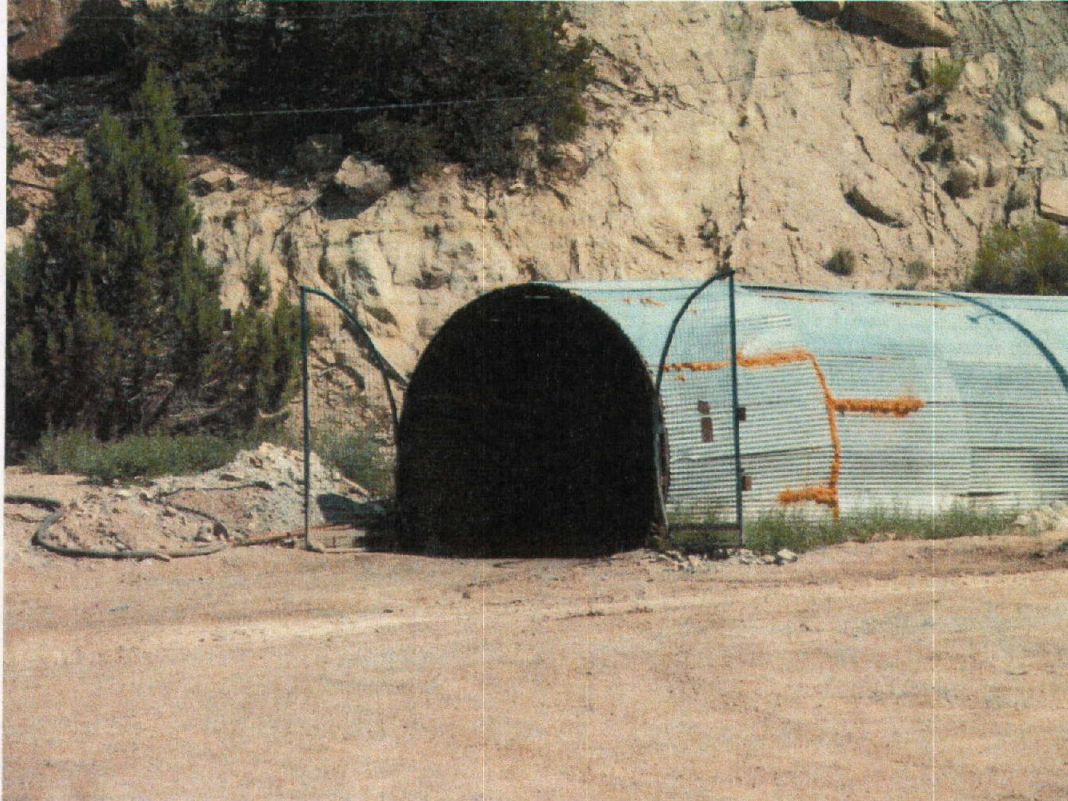
The Snowball Mine is located a short distance up the canyon from the Pandora Mine. The mine is currently idle. The portal and mine adit provides intake air for the Pandora and is also used as an alternative escape route. The mine portal is secured with a locked gate. A silt fence has been installed around the toe of the old waste rock dump. However, similar to the Pandora, no catchment basin for storm water was observed.

Snowball Mine. Top – Locked gate at mine portal; Bottom – Waste rock dump.

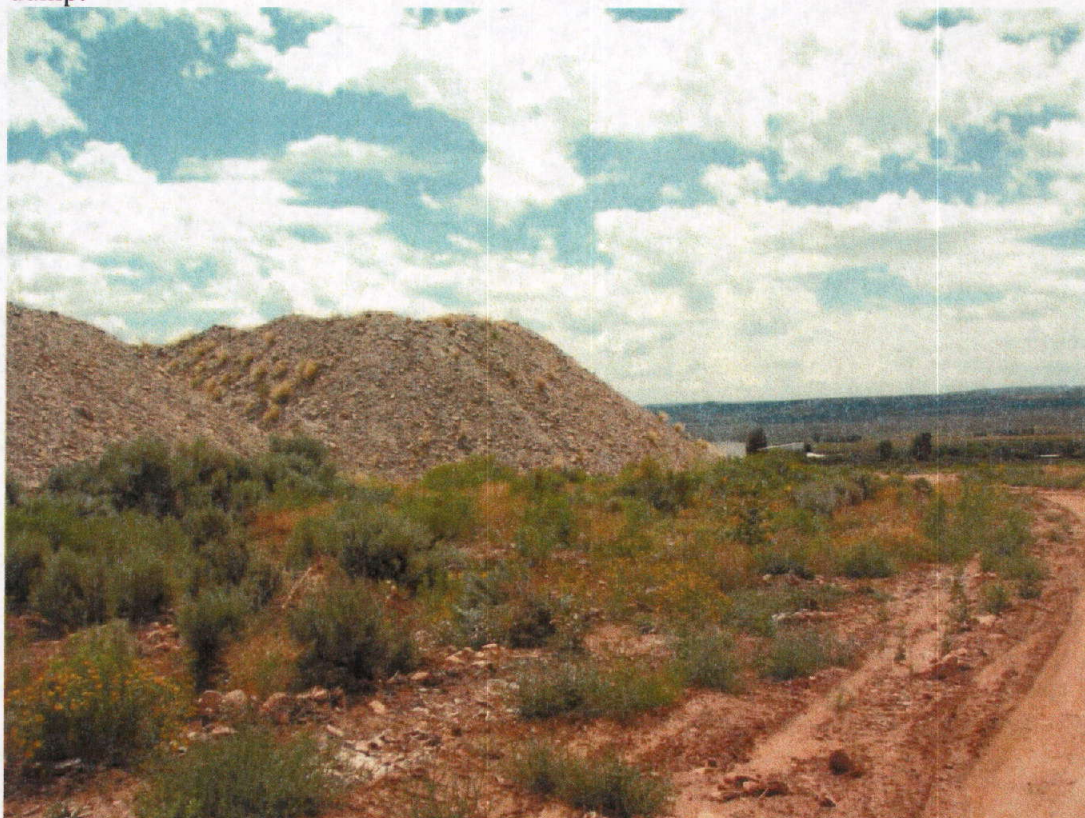
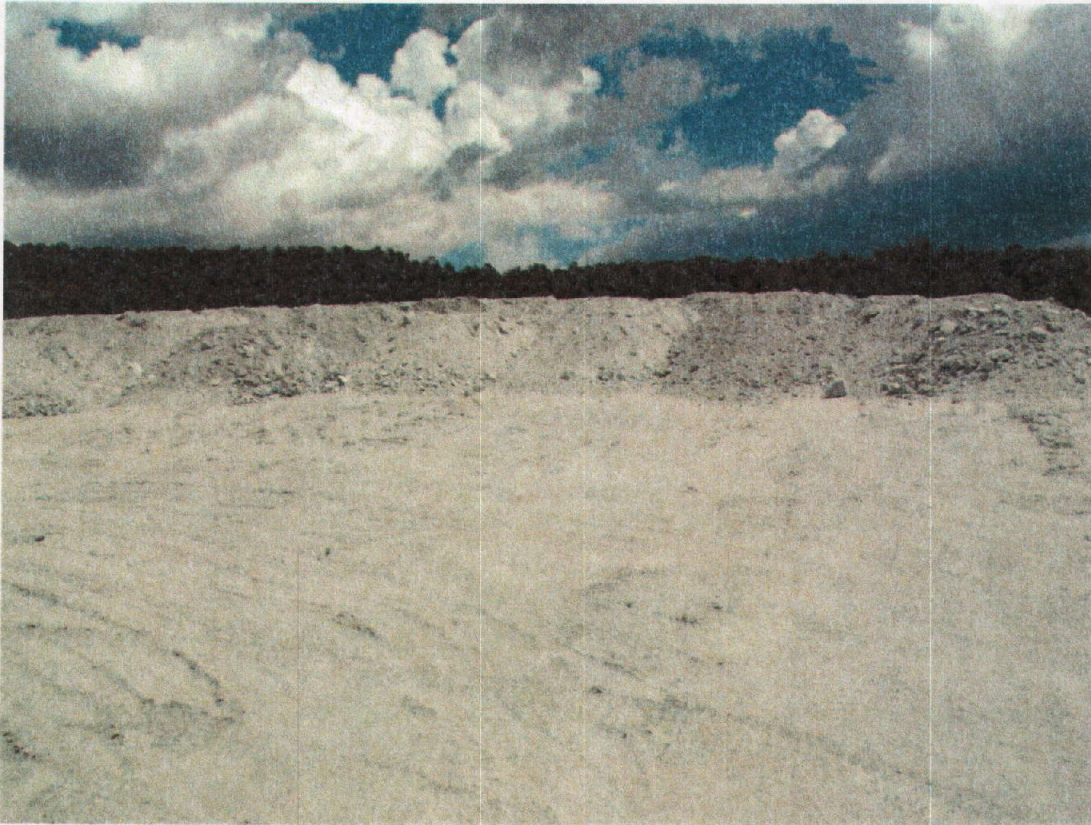
Uranium ore is currently being produced at the Beaver Shaft. Unlike the other mines in the LaSal Complex, the ore is hoisted to the surface through a shaft. Mine facilities occur on both private and BLM land. Based on a map prepared by Denison Mines, it appears that the east waste rock dump is entirely on BLM as well as a portion of the west dump. As with the other mines visited, no catchment basins were noted at the dumps to contain storm water runoff.

While visiting the east waste rock dump we observed a black bear feeding on a number of cattle carcasses just beyond the toe of the dump. According to Danny, the adjacent land owner uses the site to dispose of cattle that die during winter or occasionally throughout the year. The carcasses are not being disposed of in a pit but are scattered on the surface. Danny thought there may be up to 20-30 carcasses but he always understood the site was on private land. Based on Denison's maps, it appears the carcasses are being disposed of on BLM administered surface.

Beaver Shaft. Top – Top of east waste rock dump; Bottom – Black bear feeding on cattle carcasses near bottom of east waste rock dump.

- Unless previously authorized, the Moab Field Office may want to visit the east waste rock dump of the Beaver Shaft to determine if cattle carcasses are being disposed of on BLM surface.

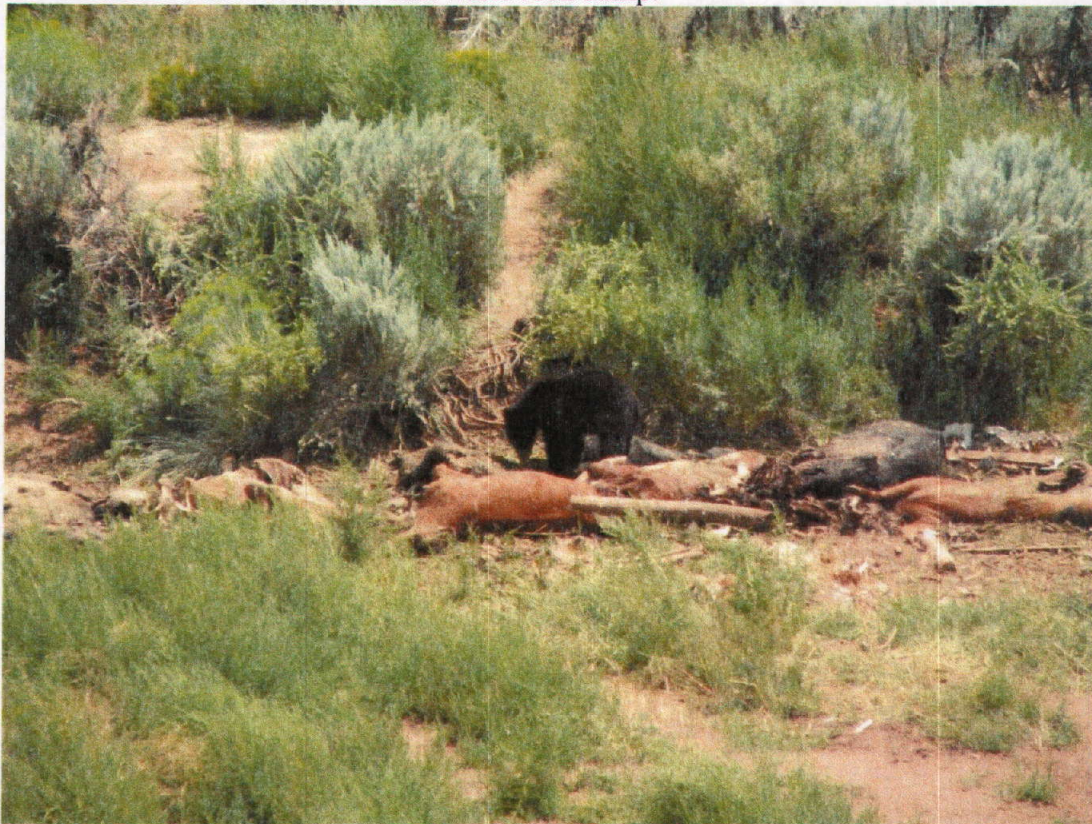
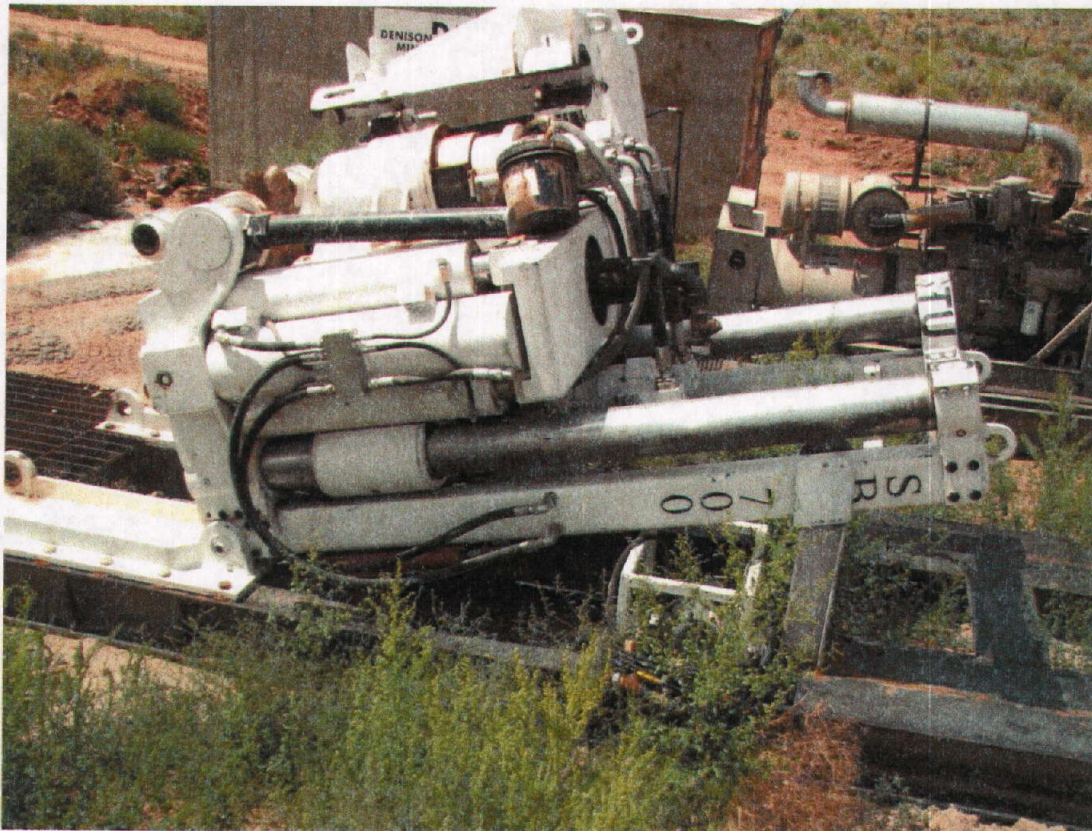
the orebody for future development purposes. While visiting the Beaver Shaft, Danny showed me the site of its recently failed vent hole operation where the ground collapsed and Denison lost the entire raise-boring machine down hole. The site is on private land.

Top – Raised-boring machine. Bottom – 8' ft head for raised-boring machine. Denison lost a similar machine when a site near the Beaver Shaft collapsed while boring a new vent hole.
